Quality Assurance and Source Inspection

Contract #: 04-0120F4Cty: SF/ALA Rte: 80 PM: 13.2/13.9File #: 1.28**WELDING INSPECTION REPORT****Resident Engineer:**Siegenthaler, Peter**Address:** 333 Burma Road**City:** Oakland, CA 94607**Report No:** WIR-023732**Date Inspected:** 17-May-2011**Project Name:** SAS Superstructure**OSM Arrival Time:** 700**Prime Contractor:** American Bridge/Fluor Enterprises, a JV**OSM Departure Time:** 1530**Contractor:** American Bridge/Fluor Enterprises, a JV**Location:** Jobsite**CWI Name:** John Pagliero**CWI Present:** Yes No**Inspected CWI report:** Yes No N/A**Rod Oven in Use:** Yes No N/A**Electrode to specification:** Yes No N/A**Weld Procedures Followed:** Yes No N/A**Qualified Welders:** Yes No N/A**Verified Joint Fit-up:** Yes No N/A**Approved Drawings:** Yes No N/A**Approved WPS:** Yes No N/A**Delayed / Cancelled:** Yes No N/A**Bridge No:** 34-0006**Component:** SAS OBG**Summary of Items Observed:**

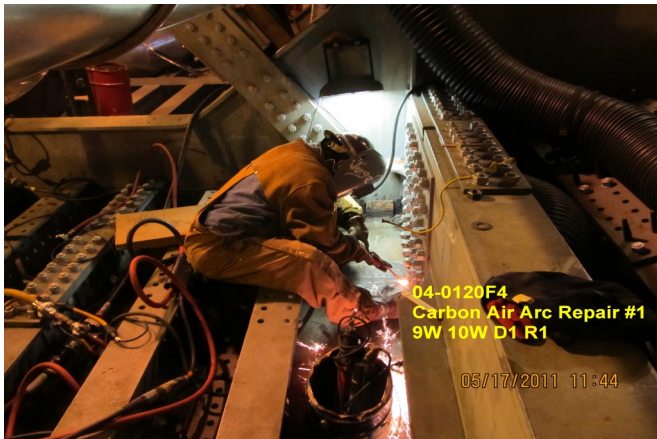
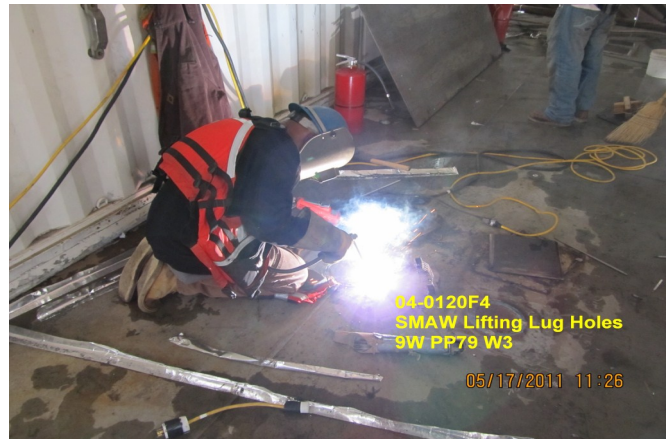
Upon approval of Magnetic Particle Testing by QC Inspector John Pagliero, ABF welder Jorge Lopez performed SMAW on location #1. The QA Inspector noted the dimensions of the excavation at y=2700 to be 150mm's in length, 30mm's wide and 20mm's deep. The QA Inspector observed the QC inspector monitor the progress and ensure the welding parameters were within the established WPS. The QA Inspector noted that the work was completed on this date and appeared to be in general conformance with the contract documents.
